Report No. 79-2

Demonstration of
MARSH TURBO THRUSH
to Deliver Pesticides
to Coniferous Forests

DECEMBER 1978

DEMONSTRATION OF THE MARSH TURBO THRUSH
TO DELIVER PESTICIDES TO CONIFEROUS FORESTS
Phase 2 - Forest Spraying

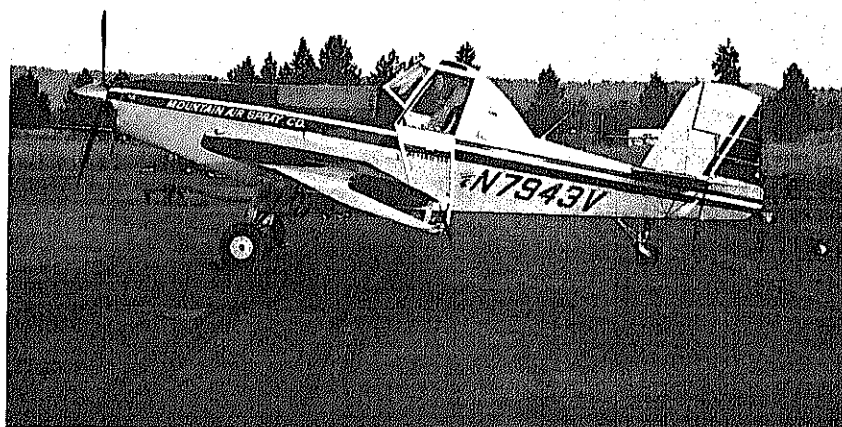
Figure 1. Marsh Turbo Thrush. Note 400-gallon hopper forward of cockpit. Turbo Thrush test, Idaho 1978.

The Marsh Turbo Thrush is the Rockwell Thrush Commander agricultural spray aircraft converted to jet prop. Marsh Aviation of Mesa, Arizona, performs the conversion and markets the aircraft (Figs. 1 and 2).

One Marsh Turbo Thrush owned by Mountain Air Spray Company, Craig, Colorado. This fixed-wing jet-prop powered (Garrett TPE-331) spray aircraft was the primary test vehicle (Fig. 1).

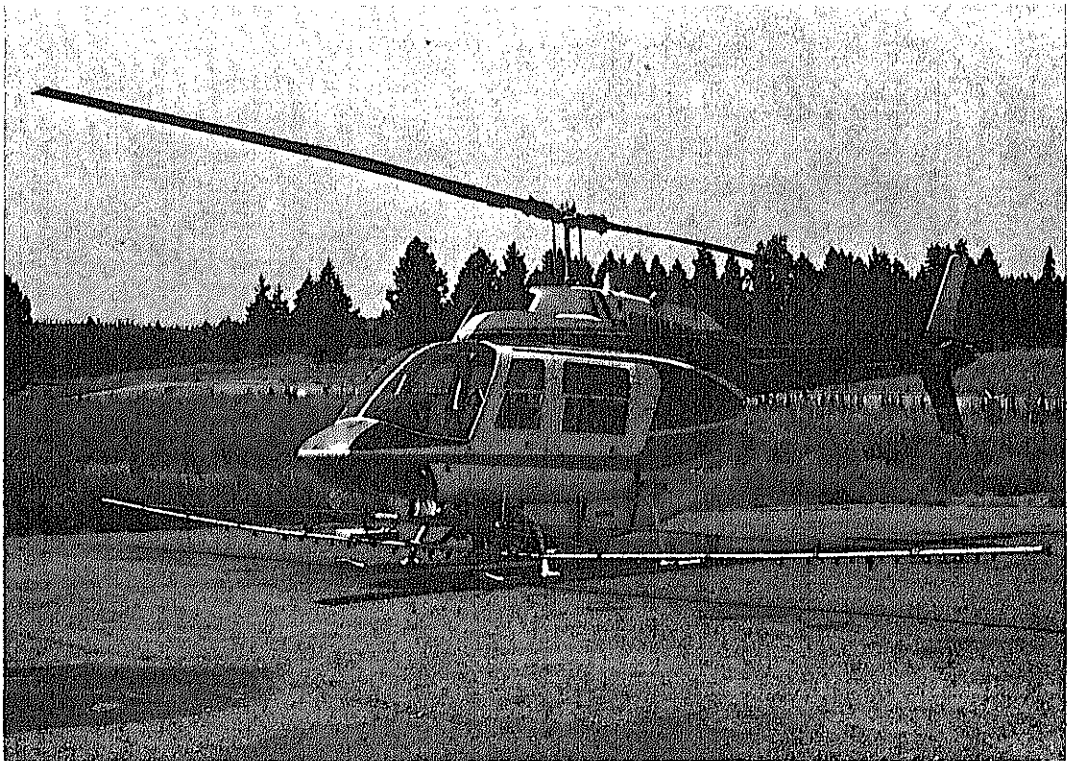
Figure 3. Bell 206B Jet Ranger helicopter with spray system. Turbo Thrush test, Idaho 1978.

We were unsuccessful in locating a helicopter capable of flying 90 mph. We were able to locate a Bell Jet Ranger (Fig. 3), capable of spray speeds of about 70 mph. Faced with the option of conducting the demonstration without a helicopter for comparison, we used the Jet Ranger.

One Bell 206B Jet Ranger owned by Cascade Helicopters, Cashmere, Washington. This was the primary spray helicopter equipped with Simplex spray system - external tank and booms (Fig. 3).

Both aircraft were calibrated at the McCall airport to deliver the one-half gallon per acre. The Jet Ranger (Figs. 3, 7, 8) was calibrated by capturing spray from a nozzle on each end of the spray boom and comparing the captured volume to time. The Turbo Thrush, with a propeller-driven Root pump system (Fig. 9), was calibrated by measuring the volume required to refill the hopper to its original level after one minute of airborne spraying. New Spraying Systems Company nozzles, screens, and tips were used on both aircraft. The Turbo Thrush was equipped with 18 TeeJet Flat Fan 8015 nozzle tips and the Jet Ranger with 28 Flat Fan 8003 tips. In an attempt to achieve a smaller drop size with the Jet
